Manhole Inspection Summary

Manhole # S11E1_009MH

Insp Date: **4/9/08 1:28 PM**

Location Address: **1500 Joh Ave**

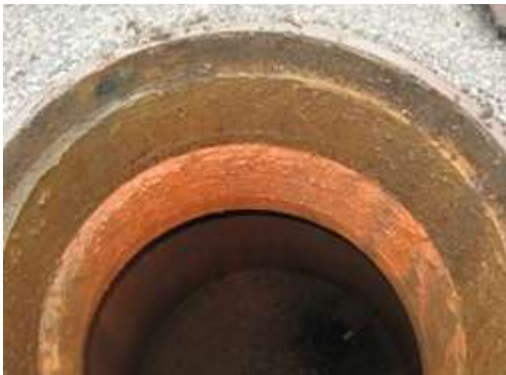
Defect 2

☒ **Joint**

Infiltration from chimney

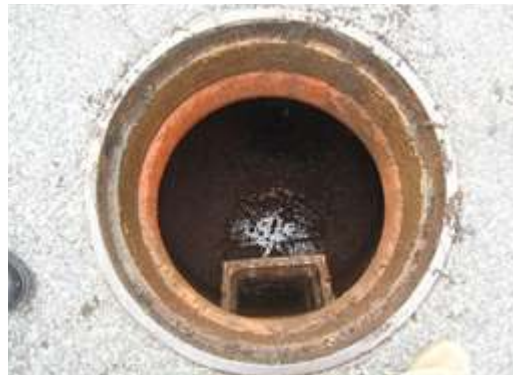
Defect 1

☒ **Leaks**

☒ **Debris**

channel debris and frame leaks

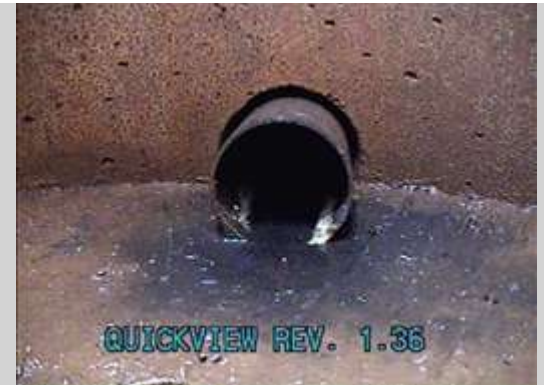
12 O'Clock Outflow

6 in. Circular Gravity Sewer
Pipe Out @ 12 O'Clock
